A mechanical review of postoperative stem fractures of cemented total hip arthroplasty implants without femoral fracture

Abstract

Background: We encountered five patients of post-THA femoral stem fracture without femoral fracture. The purpose of this study was to elucidate the mechanism underlying the observed femoral stem fractures.

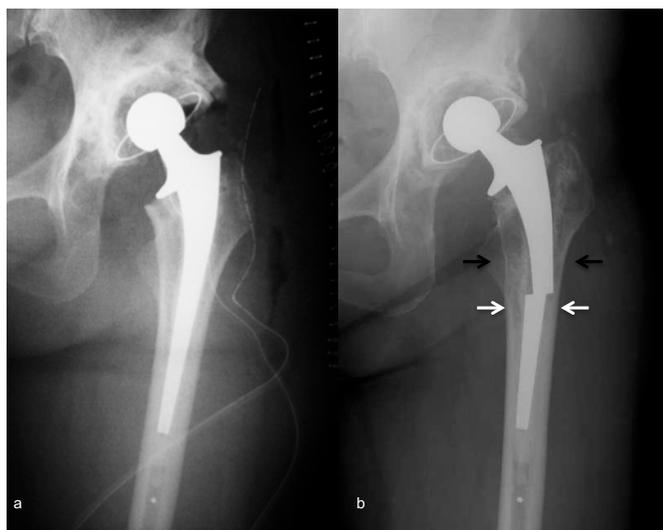
The assessment of the cement mantle on plain radiographic images taken immediately after surgery indicated grade B in all patients (Table 1). The plain radiographic images at the time of the stem fracture showed that radiolucencies were observed in all patients around the proximal regions of the stem, although good fixation was obtained at the distal portions. The radiographic images from patient 2 are shown in Figure 1. Radiolucencies were observed in the region surrounding the stem (Gruen zones 1, 7)¹¹ in areas proximal to the stem fracture. Radiolucency of the bone distal to the fracture site was observed just near the fracture (Gruen zones 2, 6)¹¹ (Figure 1).

Figure 1 Plain radiographic images
 a) Plain radiographic images taken immediately after surgery on the second patient. There was sufficient filling of cement around the distal part of the stem, but a cementation defect was observed around the proximal portion. b) Plain radiographic images at the time of fracture in the second subject. We observed radiolucency proximal to the site of the stem fracture and favorable cementation of the distal part. (black arrow Gruen zones 1, 7) (white arrow Gruen zones 2, 6)

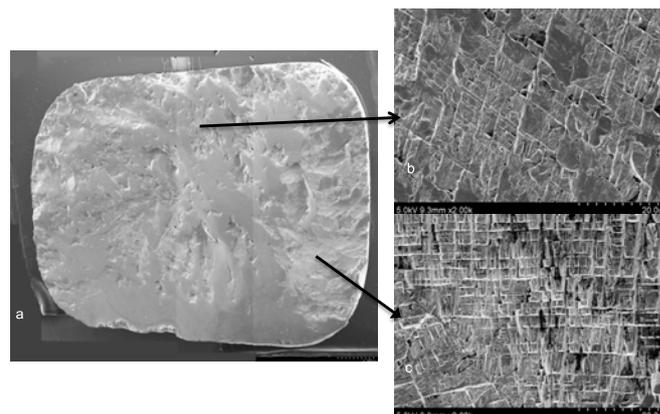
Examination of the fracture surfaces of the stems removed from all five patients during the revision surgery showed that the fracture origin was on the lateral surface in the middle of the stem. The fracture surface demonstrated a characteristic V-shape and a herringbone pattern, which resembled a series of overlapping rectangles placed at right angles to one another (Figure 2). Such a herringbone pattern is characteristic of the fracture surface of brittle materials.¹⁴

Figure 2 Examination of the stem fracture surface using a scanning electron microscope
 a) Surface of the fractured stem (Macroscopic image : scale 1.00 mm). b, c) Magnified microscope images. The arrowhead shows the herringbone pattern. (Magnification ratio b) 3.0 kV 11.4 mm×2.00 k c) 3.0 kV 10.7 mm×2.00 k: scale 20.0 μm)

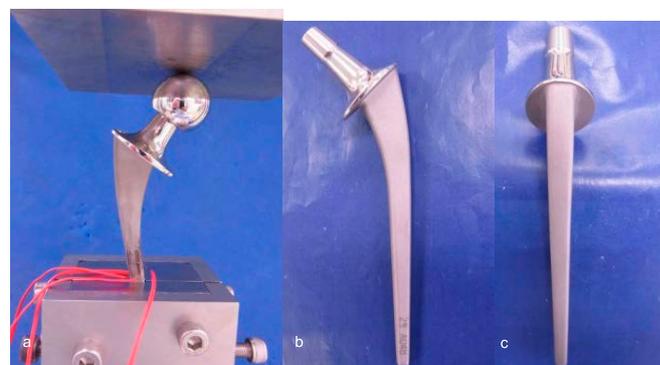
bend or fracture during the fatigue tests. Further, we did not observe any changes in the stem when we increased the number of loading repetitions from the 500×10^4 required by the standards to $3,000 \times 10^4$ (Figure 3).

Figure 3 Fatigue test
 a) Appearance of the mechanical test. b, c) The condition of the size-2 stem after the test. No changes were observed in the stem.

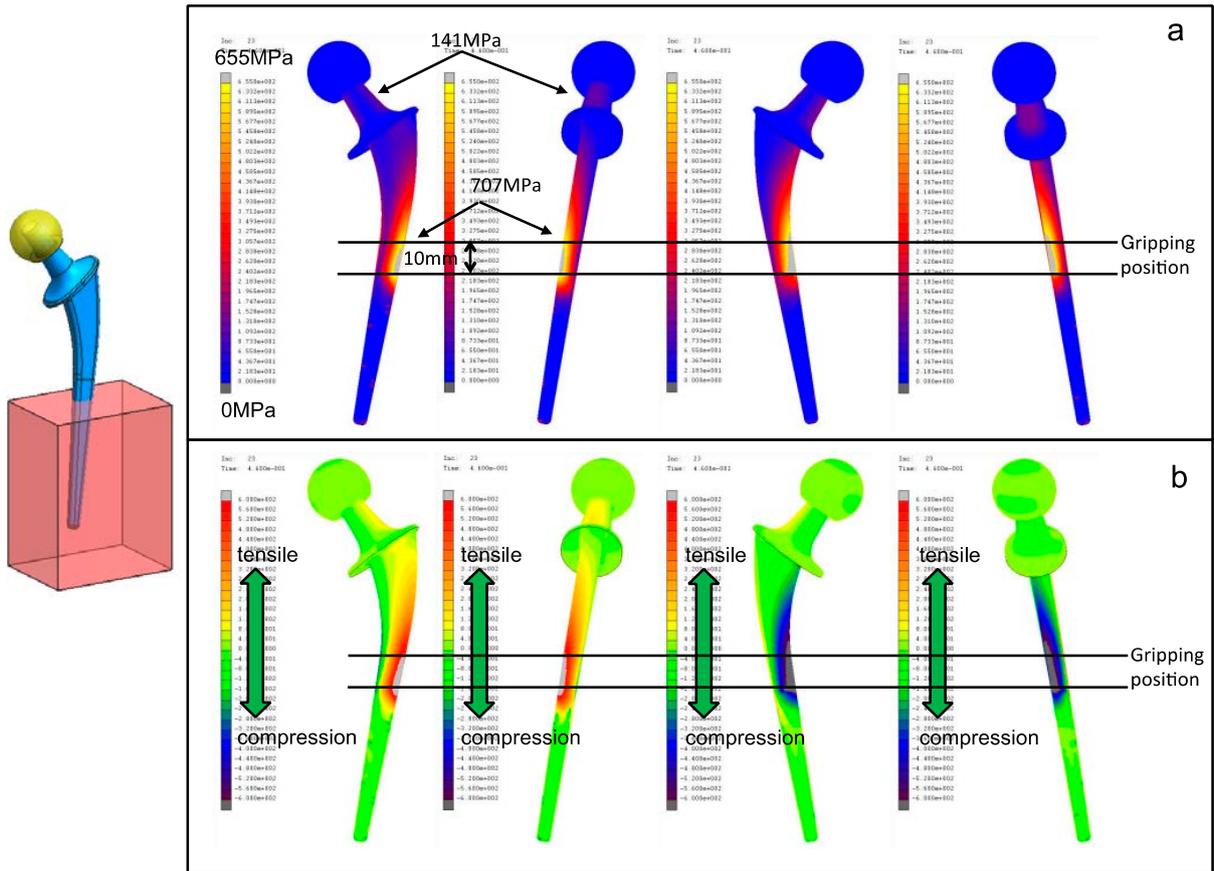
The distribution of von Mises stress determined through FEM analysis showed that the stress was the highest in the center of the stem, whereas tensile stress was distributed more laterally and compression stress was distributed more medially. In other words, the lateral part of the center of the stem was exposed to a maximum amount of tensile stress, with this area corresponding to the stem fracture origin that was predicted when examining the fractured surface (Figure 4).

Figure 4 Finite element method analysis
 a) The distribution of von Mises internal stress showed a high internal stress level in the medial and lateral parts of the center of the stem. b) In terms of stress distribution, tensile stress was chiefly distributed to the lateral part and compression stress was distributed to the medial part.

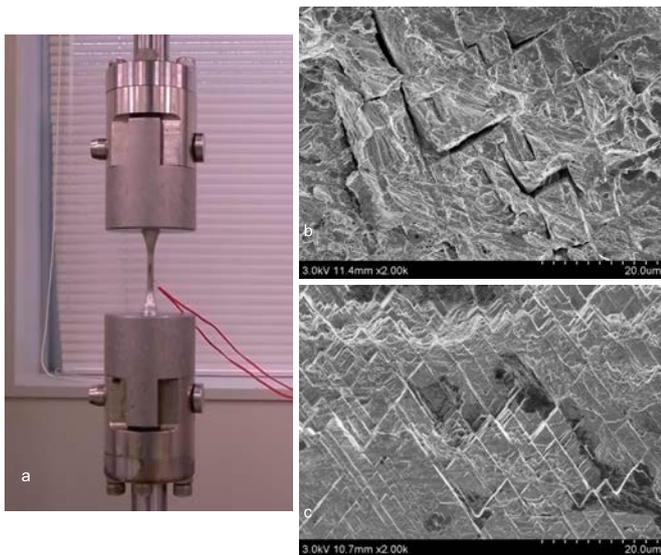
The presence of a herringbone pattern was noted on the fracture surfaces of the dumbbell tensile test pieces in the material tests and particularly during the fatigue strength tests. Based on the above, we are able to interpret the cause of the herringbone pattern that is present on the fatigued fracture surface of materials containing Co-Cr alloys (Figure 5).

Figure 5 Static and fatigue strength tests
 a) Appearance during the tests. b) Magnified microscopic images of the static tests. c) Magnified microscopic images of the fatigue strength tests (Magnification ratio b) 3.0 kV 11.4mm x2.00 k c) 3.0 kV 10.7 mm x 2.00 k; scale 20.0 μm). A herringbone pattern was observed at the fracture surface of the test pieces during the static tests, and particularly during the fatigue strength tests.
